**GENERAL CONDITION
ASSESSMENT REPORT**

**LILLOOET MUSEUM &
VISITOR CENTRE**

**790 MAIN STREET
LILLOOET, BC**

Date: October 30, 2009
Project No. 1446-09009

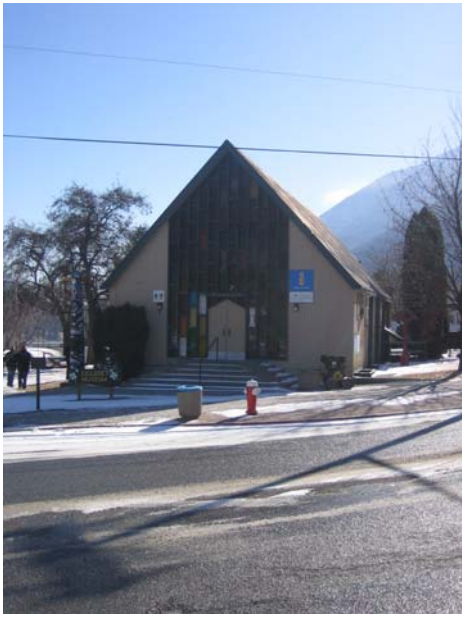
Image - A01

impractical to replace the stained glass units with more energy efficient units.
(See image A01)

- The windows on the north face are original to the building and are in fair condition however it is recommended that a detailed structural review be conducted with respects to wind loading and the installation of structural mullions. (See image A01)

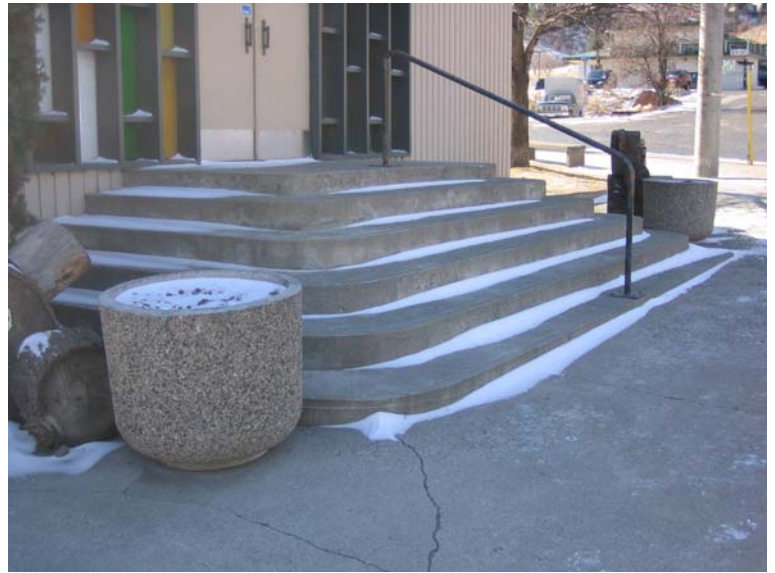
Image - A02

- The main entrance to the facility does not have a ramp for persons with disabilities. It is recommended that a ramp be constructed to provide access for people with disabilities. (See image A02)
Opinion of probable cost: \$15,000.00

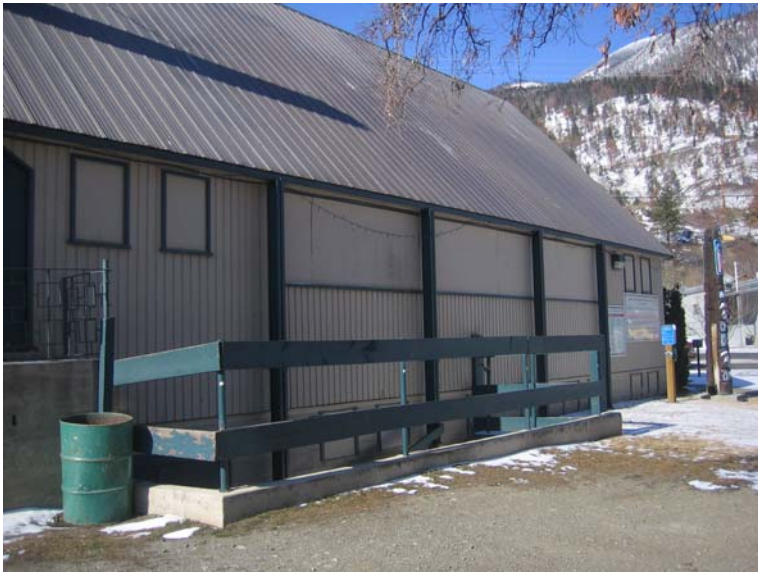
Image - A03

The exterior windows on the East and West sides of the building have been removed and replaced with plywood panels (See images A03, A10 and A26). The stain glass windows on the North and South faces appear to be original to the building. The stain glass window on the North face appears to have no structural mullions. It was noted that during strong wind storms, the windows and walls on the North shake violently. All glazing in these windows is single pane. The exterior doors are solid core wood doors in wood frames and appear to be original to the building.

- The exterior windows which were removed and replaced with plywood panels should be replaced with insulated panels.
Opinion of probable cost: \$1,500.00
- Confirmation of insulation levels of the main floor exterior walls and roof assemblies is recommended and should increase where possible.
Opinion of probable cost: \$1,500.00 (Insulation investigation)
- Install new weather stripping around all exterior doors.
Opinion of probable cost: \$500.00
- Replace all caulking around all exterior doors and windows.
Opinion of probable cost: \$500.00
- The basement walls appear to have no insulation. We recommend that rigid insulation be installed to all basement walls.
Opinion of probable cost: \$15,000.00 (New rigid insulation and installation of new wood paneling to match existing or reuse existing paneling if possible)

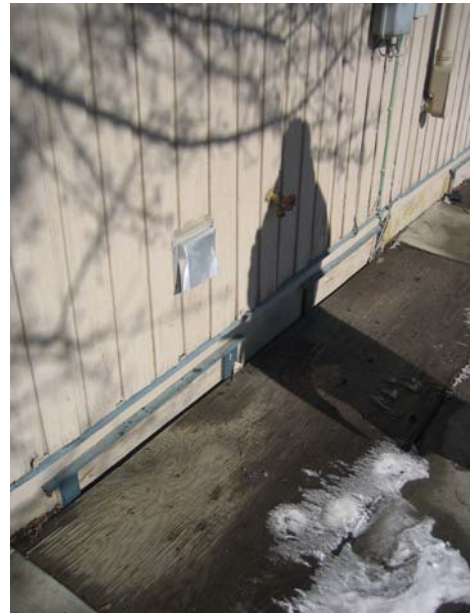
Image - A04

- The existing window wells are constructed of wood and are showing signs of severe deterioration. Several window wells which are fully open are a potential fall hazard. It is recommended that all of the window wells be reconstructed with a concrete curb and a protective cover be installed to prevent a possible fall hazard. (See image A04 and A05)
Opinion of probable cost: \$5,000.00

- The guard rail around the East side loading ramp area is not code compliant and should be replaced with a non-climbable structure. (See image A04 and A07)
Consideration to future expansion should be considered.
Opinion of probable cost: \$1200.00

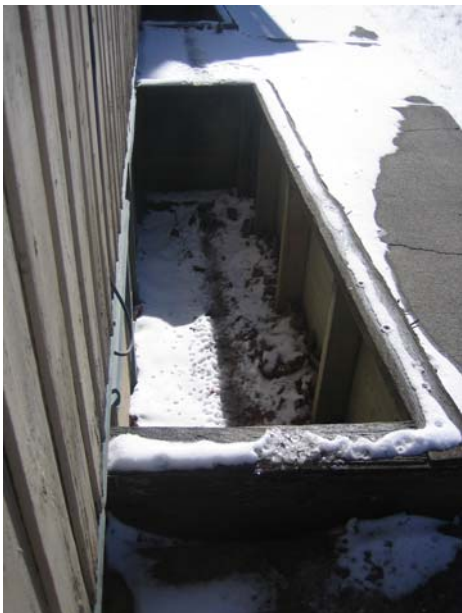
Image - A05

- The vertical wood siding in several areas is showing signs of rot. It is recommended that all damaged wood siding be replaced prior to painting the building. (See image A05)
Opinion of probable cost: \$5,000.00 (Minor repairs)

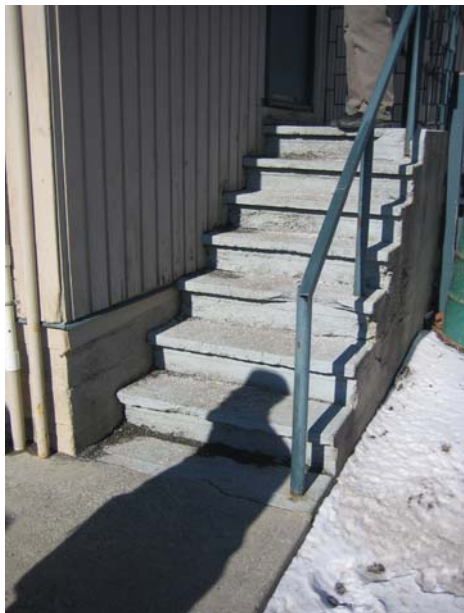
Image - A11

- The concrete stair at the rear entrance is crumbling and the hand rail is not code compliant. It is recommended that a new entrance stair be constructed. See image A11)
Opinion of probable cost: \$3,000.00

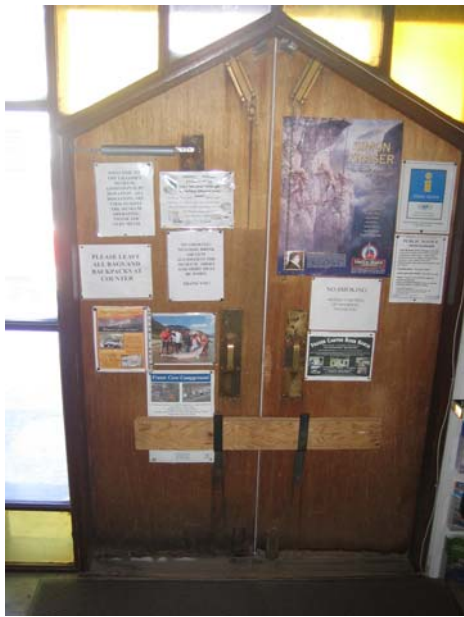
Image - A19

- The main entry door requires proper exiting hardware. A finished 2x6 and brackets is not code compliant exiting devices, **see BCBC 3.3.1.13**. (See image A19). New existing hardware is recommended.
Opinion of probable cost: \$700.00
- The interior stair handrail is not continuous and does not meet current building code standards. It is recommended that a new code complaint handrail be installed, **see BCBC 3.4.6.4**.
Opinion of probable cost: \$700.00
- The interior vestibule has no access ramp at the interior stair leading to the main display area. It is recommended that a new code compliant ramp be constructed to provide access for people with disabilities.
Opinion of probable cost: \$3000.00
- Install all new fire extinguishers through out facility.
Opinion of probable cost: \$350.00

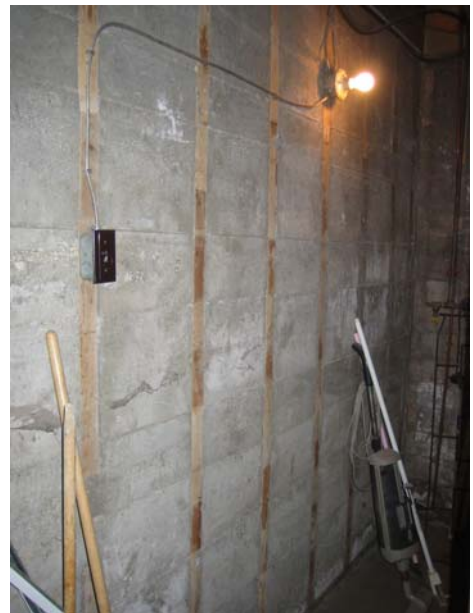
Image - A30

The foundation walls are assumed to be reinforced cast-in-place concrete with vertical wood furring cast-in-place (See image A30). The foundation walls are assumed to be founded on cast-in-place concrete footings, size unknown. The basement walls are finished with wood paneling. Insulation does not appear to be present on the basement walls. The east side exterior foundation wall has experienced severe displacement by roots of a large tree which has been removed. The structural review will discuss this issue in more detail.

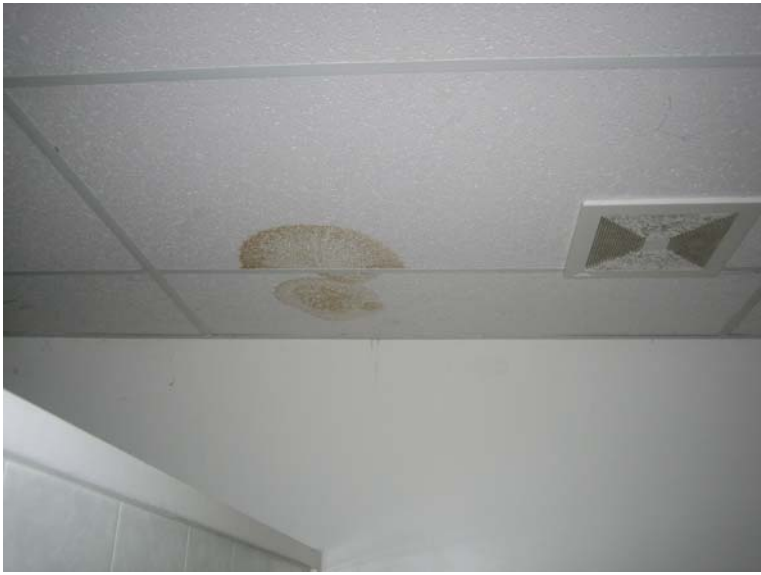
Image - A31

- The main floor structure appears to be loaded to capacity. The floor joists are sagging in the middle of the floor. We recommended that the large concentrated loads be removed from the floor and a detailed structural analysis be conducted to determine if the upper floor structure has been compromised. (See image A18)
Opinion of probable cost: Refer to Structural (removal of existing finishes will be required.)
- Water damage was observed in many ceiling tiles in the basement washroom. We recommend further investigation be undertaken to determine the cause and

extent of the water damage and that all damaged ceiling tiles be replaced. (See image A31)
